# Use of Non-Certified Equipment on Cockpit Windows

The use of non-certified equipment, like sunshades or suction cup mounted devices, on the inner surface of cockpit windows may create risks to the windows integrity and therefore aircraft safety.

This document highlights the risks associated with non-certified equipment used on cockpit windows. It provides operational recommendations to flight crews and recalls that certified tablet holders, mounted on the windows' frame, are available as a safe alternative.

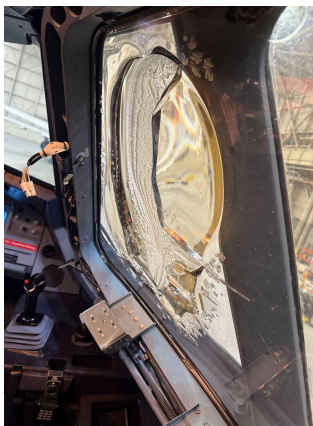
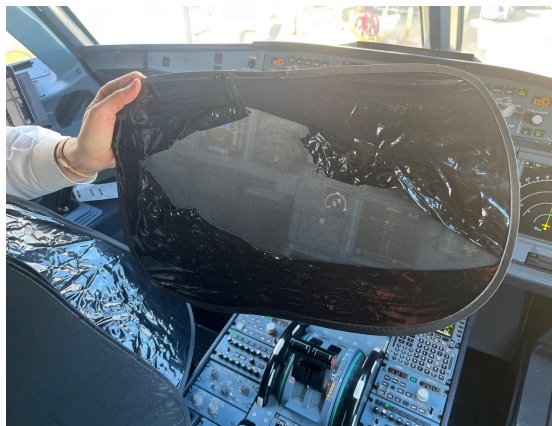
The flight crew did not observe any immediate problems on the right windows after the ECAM alert triggering. However, after a short period, the right sliding window became hot and started to become distorted.

During final approach, when passing through 1 000 ft, the flight crew heard a crack in the right window. They landed safely at the diversion airport.

Postflight inspection found severe damage to the right sliding window. The sunshade that was covering the window also displayed heat damage (**fig.1**).

**(fig.1)** Damage observed on the RH sliding window and on the sunshade (pictures from the Operator)

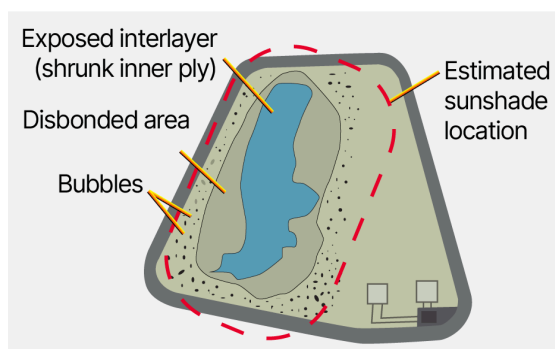
Detailed inspection by the manufacturer revealed that "the window experienced excessive temperature at the inner ply. The excessive temperatures had caused thermal relaxation of the inner ply to such an extent that the inner ply had fully relaxed back to expose the interlayer over a large area."

**(fig.2)** Mapping of the damage of the sliding window

The windows manufacturer also described that "Non-destructive thickness measurements taken of the outer ply in conjunction with visual assessment concluded this ply to be undamaged. As such the window can be considered to remain failsafe." The structural integrity of the window was therefore still maintained.

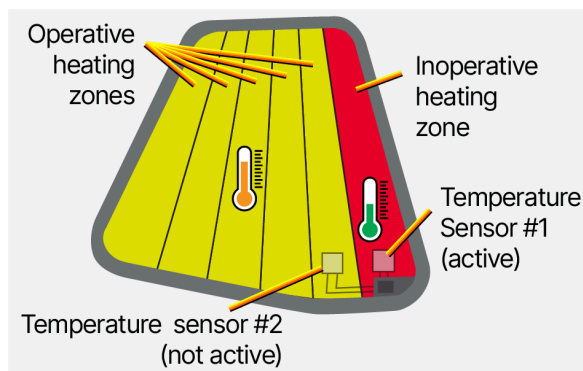
The heating film adjacent to the active<sup>(\*)</sup> temperature sensor was found to be inoperative. This failure on this type of window can cause the window heating system to incorrectly estimate the temperature of the window, resulting in an increase in temperature of the window areas with a functional heating film.

**(fig.3)** An inoperative heating zone caused a dysfunction of the window temperature regulation

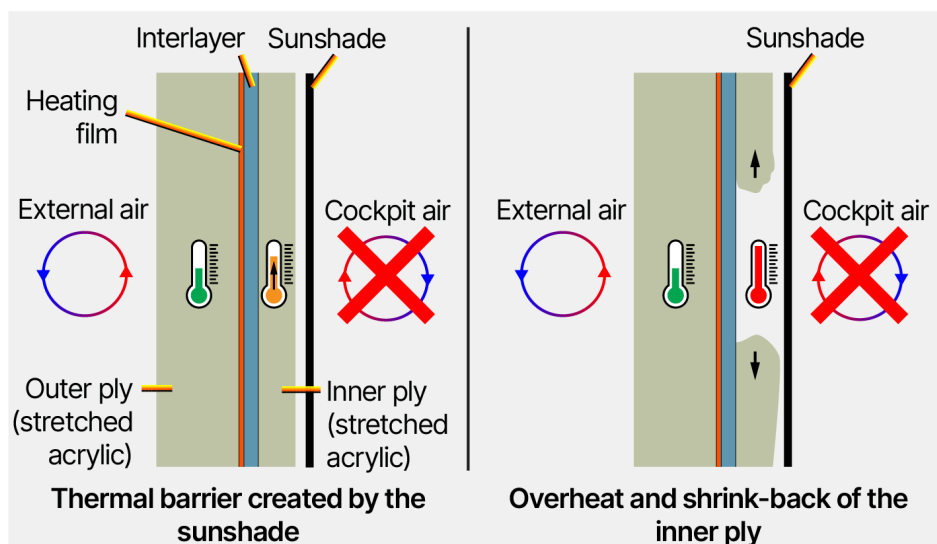
The sunshade applied on the window acted as a thermal barrier, preventing natural cooling of the inner side of the window by convection of the cabin air on the window surface **(fig.4)**.

The combination of the overheating, caused by the faulty heating system with the thermal barrier effect created by the sunshade resulted in the temperature of the inner ply to go above the acrylic material's glass transition temperature. This caused the inner ply to be affected by a shrink-back effect causing the damage.

**(fig.4)** The sunshade prevented the natural cooling by the cockpit air circulation, causing the overheating and shrink back of the inner ply

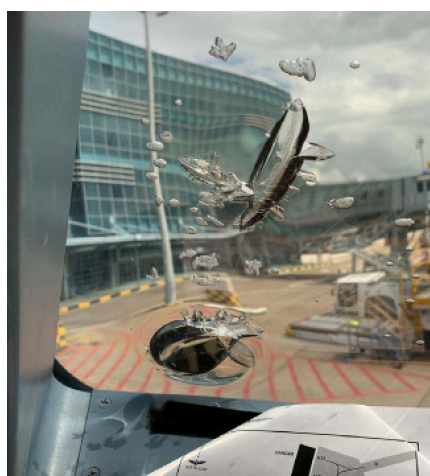
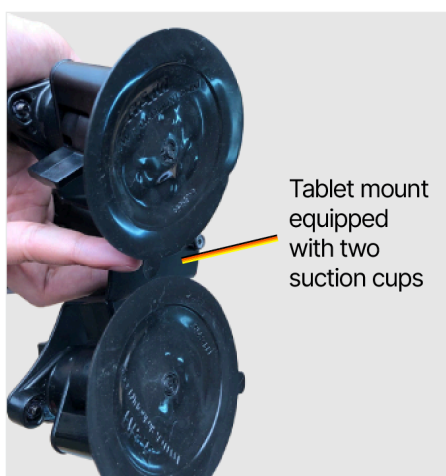
The event described earlier in this article illustrates the thermal barrier effect of a sunshade. However, suction cups used to attach different types of equipment on the windows can also act as a thermal barrier. This can affect the local cooling of the covered area. When combined with a loss of the temperature regulation of a window, this can cause significant damage to the window (**fig.6**).

**(fig.6)** Example of damage caused by a loss of the temperature regulation of an acrylic sliding window combined with the use of a tablet mount equipped with two suction cups (pictures from the Operator)

In general, flight crews should avoid attaching any equipment to the inner surface of the cockpit windows. This practice is advised to prevent the risks previously described.
